# Manhole Inspection Summary

Manhole # S21WW1023MH

**Location** Address: **5113 FALLS RD** Cross Street: **SPRINGHOUSE PATH**

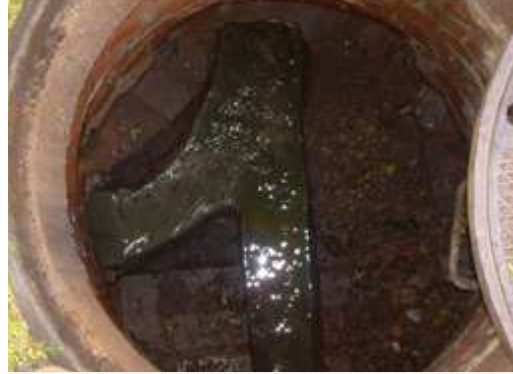
Top View

**Bench** ☒ Exists Material: **Brick** ☐ Parged ☒ **Debris** (not Condition related)  
Condition: ☒ Sound ☐ Cracked ☐ Root Intrusion ☐ Deteriorated ☐ Leaks ☐ Debris

**Surcharge** ☒ **Evidence Of Surcharge** Depth: **1** (ft.) ☐ Active Surcharge Present

Evidence of surcharge - Bench debris.

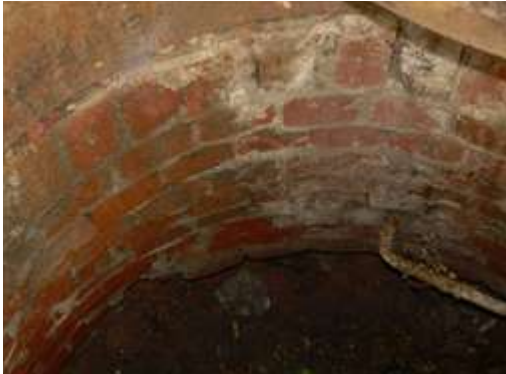
Defect

**Frame** Offset: **0** (in.) Condition: ☐ Sound ☐ Cracked ☒ **Leaks**

**Chimney / Frame Adjustment** ☒ Exists Material: **Brick** ☐ Parged Height: **4** (in.)  
Condition: ☐ Sound ☐ Cracked ☐ Root Intrusion ☐ Loose Brick ☒ **Deteriorated**  
Infiltration: ☐ None ☒ **Joint** ☐ Cracks ☐ Mortar ☐ Roots ☒ **Wall**

**Corbel** Material: **Brick** ☐ Parged Type: **Concentric/Eccentric**  
Condition: ☒ Sound ☐ Cracked ☐ Root Intrusion ☐ Loose Brick ☐ Deteriorated  
Infiltration: ☐ None ☐ Joint ☐ Cracks ☐ Mortar ☐ Roots ☒ **Wall**

Frame leaks. Adjustment deterioration and infiltration. Corbel and Barrel infiltration.

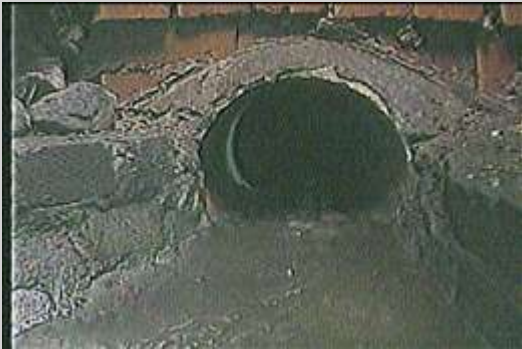
### 10 in. Circular Gravity Sewer Pipe Out @ 12 O'Clock

**Channel** Material: **Brick** ☐ Parged ☐ Debris (not Condition related)  
Channel Exposure: **Fully Open** Junc Dist: **0** nearest .5 ft. Azimuth:  
Condition: ☐ Sound ☐ Cracked ☐ Root Intrusion ☒ **Deteriorated** ☐ Leaks ☐ Debris

Channel deterioration.

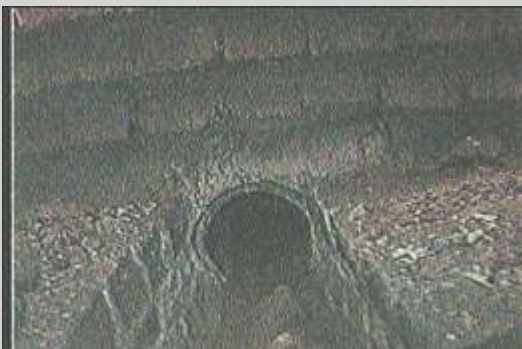
### 6 in. Circular Gravity Sewer Pipe In @ 6 O'Clock

Deposits: ☐ None ☒ **Mud** ☐ Sludge ☒ **Debris** ☐ Grease

Infiltration: **Evidence** Pipe Seal Cond: **Unknown**

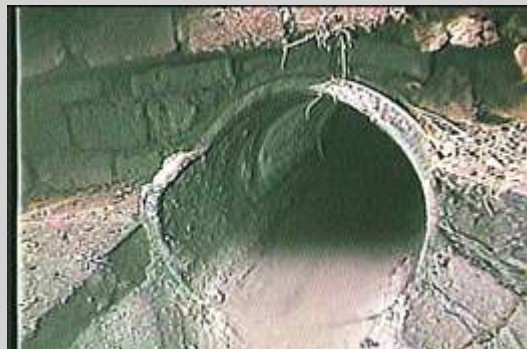
Pipe In @ 9 O'Clock

**Barrel** Material: **Brick** ☐ Parged  
Shape: **Circular** Diameter: **42** (in.) Length: (in.)  
Condition: ☐ Sound ☐ Cracked ☒ **Root Intrusion** ☐ Loose Brick ☒ **Deteriorated**  
Infiltration: ☐ None ☐ Joint ☐ Cracks ☒ **Mortar** ☒ **Roots** ☐ Wall

Barrel deterioration, root intrusion and infiltration.

Infiltration: **None** Pipe Seal Cond: **Broken**
